ACTION: Consider one application for Chapter 3 Emergency Mineral Royalty Grant for Teton County

Name of Project: Wagon Road Slide Repair

Engineer's Opinion of Probable Cost SNAKE RIVER SPORTING CLUB WAGON ROAD SLIDE REPAIR

Re: WYDOT Review of Wagon Road Slide Emergency Application

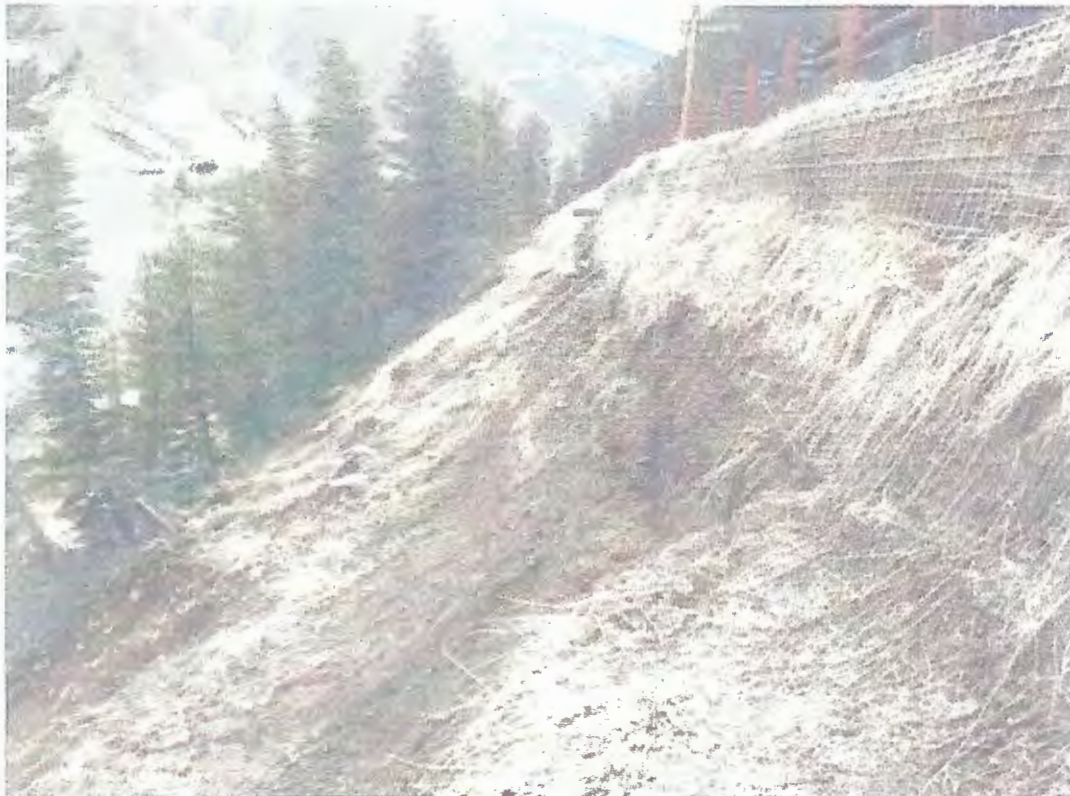
Existing Hilfiker Wall and Slope Condition from STA 1+20 (Wall Toe) Looking Northwest – April 10, 2017

Soil nail reinforcement through the existing Hilfiker wall and into the embankment, coupled with micropiles at the toe of the existing wall to mitigate against additional loss of toe and undermining, is an appropriate stabilization measure for this area. The nails and micropiles will be tied together structurally with steel-reinforced shotcrete. The outboard roadway lane and shoulder between STA 2+17 and STA 2+45 will be re-built with a geosynthetically confined soil (GCS) embankment section.

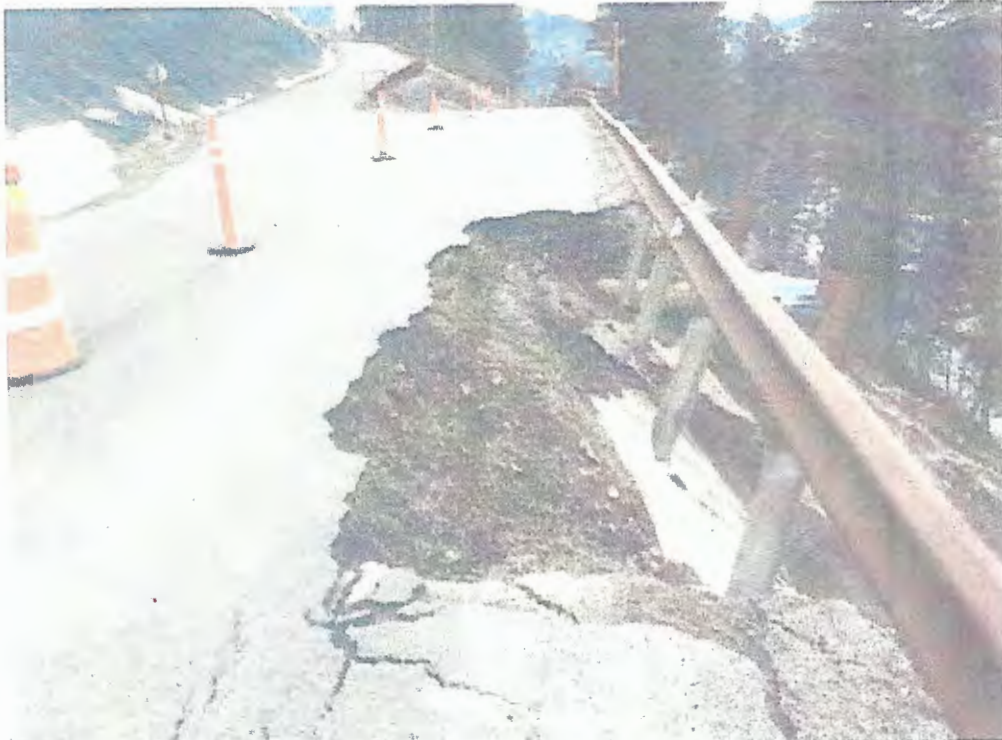
Existing Roadway Condition @ STA 2+50 Looking Southeast – April 10, 2017
